Inspection Report
Minerals Regulatory Program
Date: October 9, 2008

Mine Name: Sandy Wash 4/Blawn Mtn.	Permit Number: S0010063
Operator Name: Nell. Sandy	Inspection Date: 10/02/2008
Inspector(s): Brett Gregory (for Tom Munson)	Time: 2:30 pm
Other Participants: None	Mine Status: Active

Purpose of Inspection: This was a routine annual inspection.

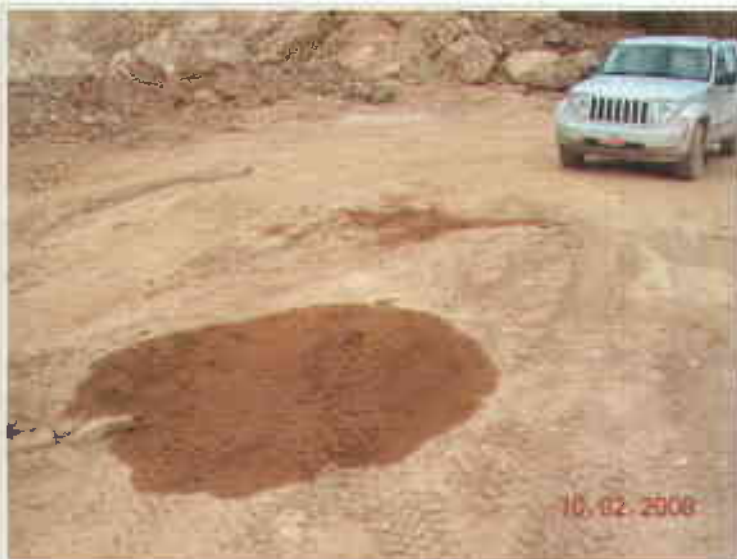
Fluid spill from heavy equipment.

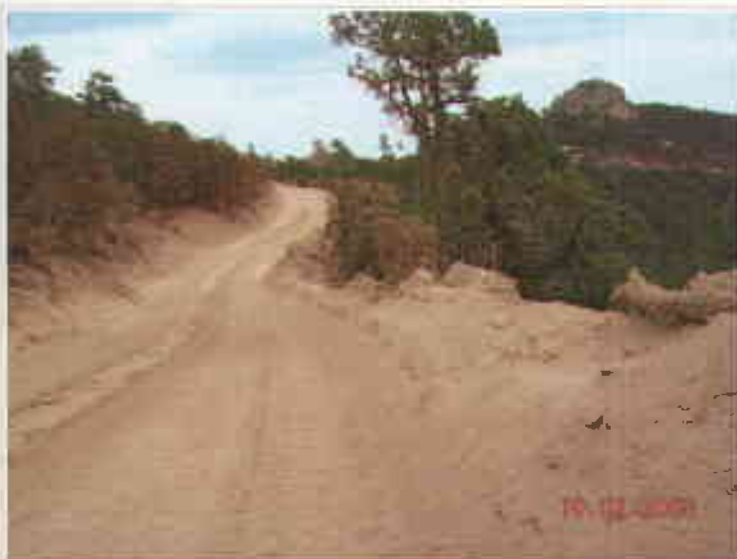
5. The access road definitely could use a water truck. Seeing as how the road belongs to the BLM, they may take issue with it for dust control and maintenance.

Access road.

Conclusions and Recommendations: Bring in a water truck for erosion control. A catch-bench may also need to be factored in for safety from rolling rocks and slope failures. DOGM will continue to monitor this site.

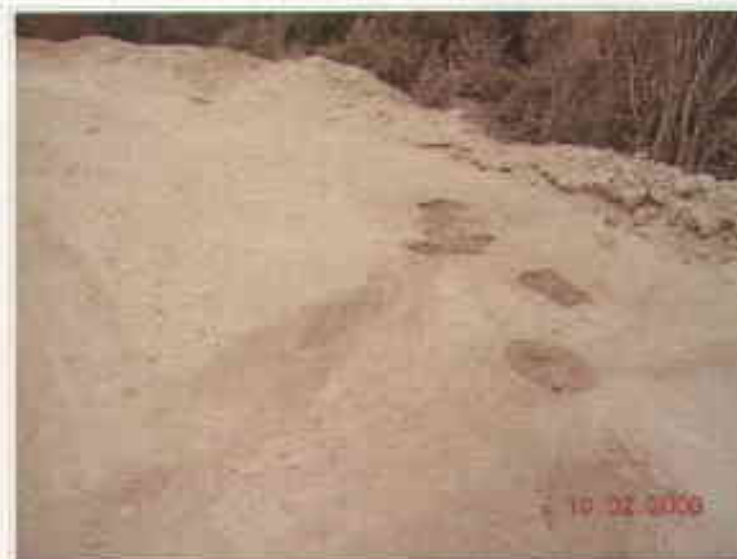
Dust control and road maintenance needed.

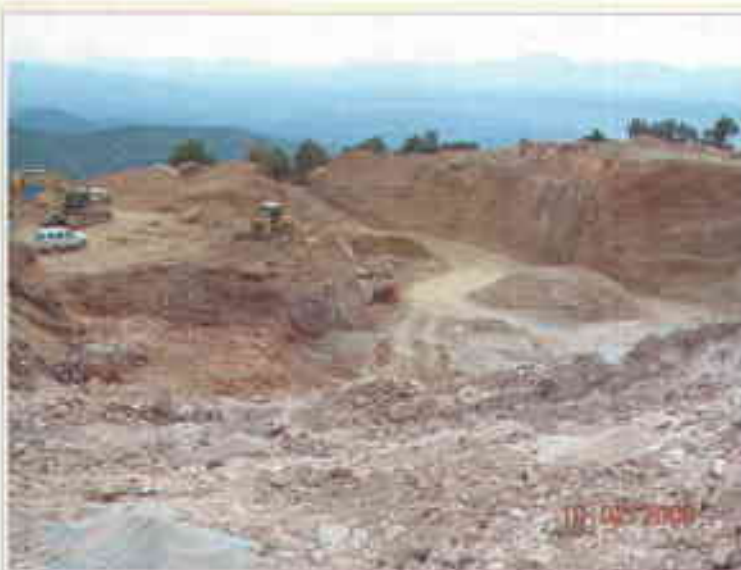
7. I noticed several shallow drill holes that need to be either backfilled with cuttings or mined through. The highwall also appears to be getting rather large for a small mine.

Exploration holes.

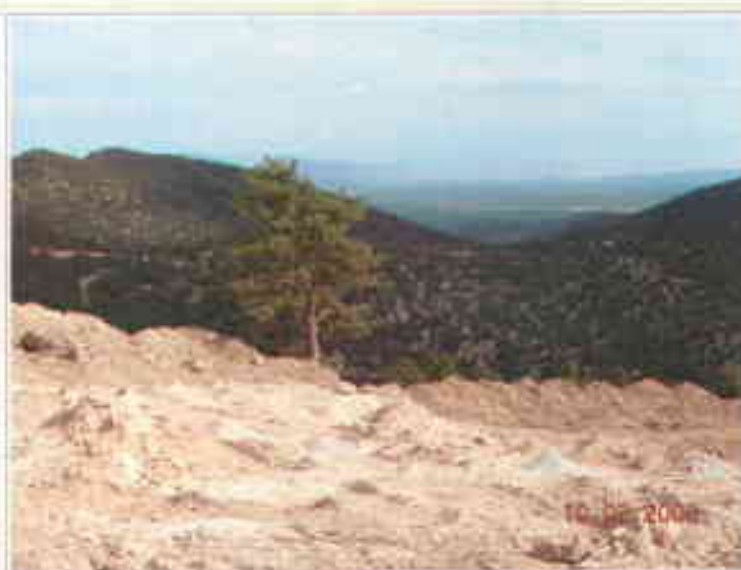
Cuttings need to be put back in the drill holes after exploration.

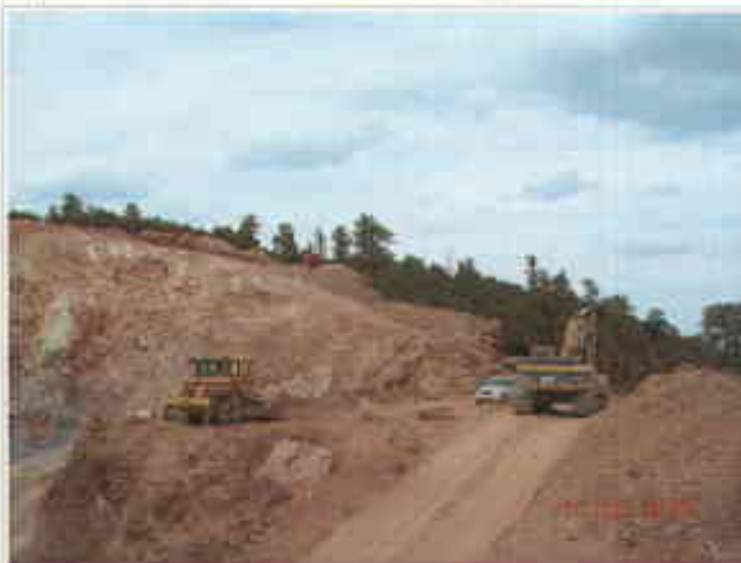
Machinery found on site

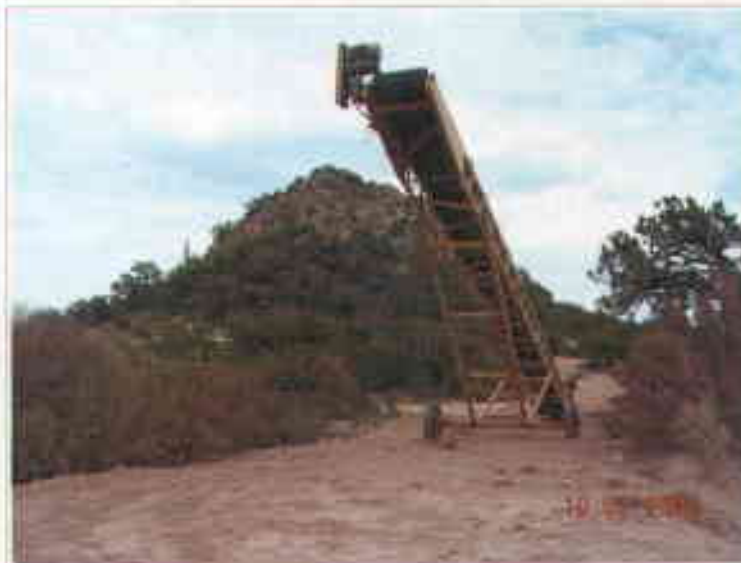
Conveyer belt blocking the road
